The 2004 Indian tsunami in Thailand: Surveyed runup heights and tide gauge records

Key words: The 2004 Sumatra earthquake, tsunami, field survey, Thailand, tide gauge record.

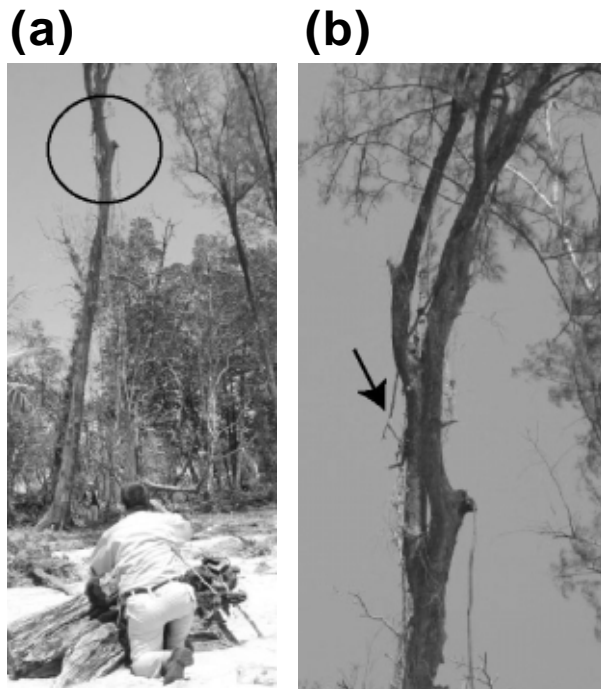
Photo 2. (a) Broken branches due to the tsunami current at Ban Tung Dap, and (b) zoomed up of the circle.

We visited Ban Thung Dap that is located on the southwest of tip of Ko Phra Thong Island. The tsunami height of 19.6 m was found, which is the highest record of our survey on the Thailand coast. This height was measured by the broken branch of a tree due to the tsunami current (Photo 2). This is not a single evidence, but we could also find several evidences at the same level on other trees here.

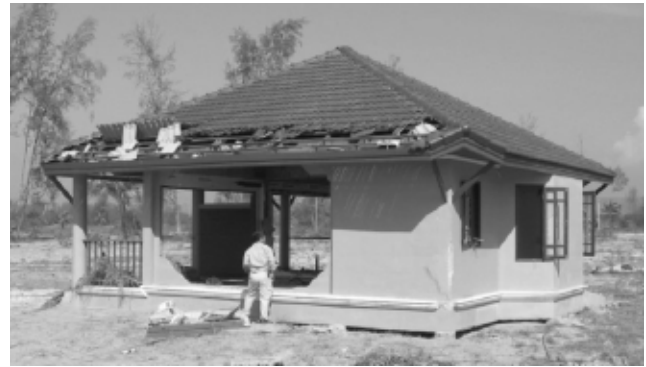
Photo 3. Damaged house by the tsunami at Ban Ma Kap.

Ban Ma Kap is located at the south of Ko Koh Kao Island, and the ferryboat from Ban Nam Kim is served every hour. Both walls and a roof of an one-story house were broken as shown in Photo 3. The tsunami height was estimated to be

6.0 m. We considered that the sea water reached at least the damaged upper most tile of the roof. The population of Ko Koh Kao Island was about 800 before the tsunami. About 400 people were killed due to the tsunami, while most of those casualties were not residents but temporal workers from out of the island.

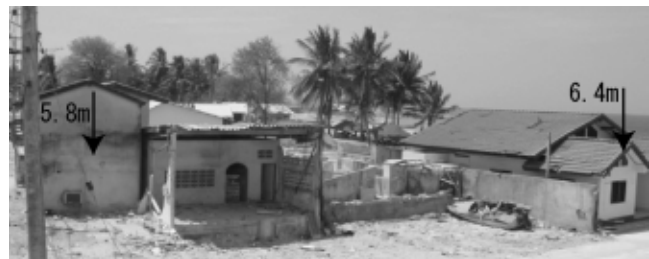
Photo 4. Tsunami height at Ban Nam Kim.

We could measure two tsunami heights that are close to each other as shown in Photo 4, and both of them were based on the water marks of 5.8 m and 6.4 m left on the walls. The distance between two water marks of about 50 m was too far to derive the current speed. This is why the effects of the dissipation are not negligible and the

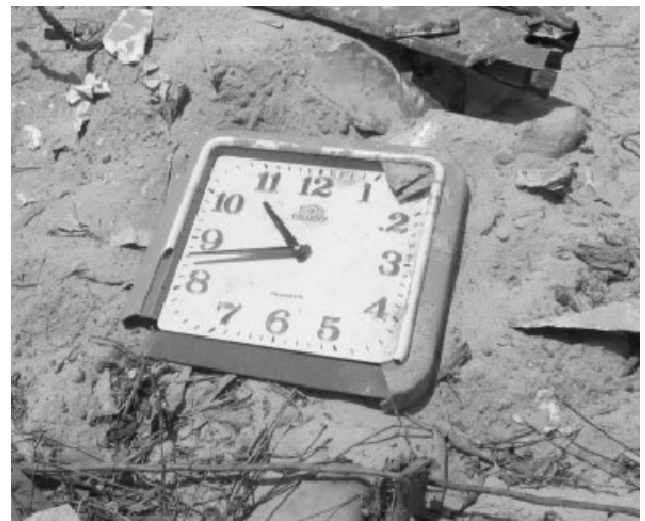
Photo 5. Broken clock at Ban Nam Kim.

Bernoulli (the Torricelli) theorem cannot be applied. We found a clock broken by the tsunami, which stopped at 10:42 (Photo 5). There still remains a doubt that it was correctly working at that time, while the resident in Ban Nam

Kim said the tsunami attacked at about 10:30. It means the tsunami attacked after about 2 hours and 30 minutes from the outbreak of the main shock. The main residential area of Ban Nam Kim extends south of these buildings.
